Manhole Inspection Summary

Manhole # S19MM_003MH

Insp Date: **7/5/07 9:37 AM**

Location Address: **2231 ELGIN AVE**

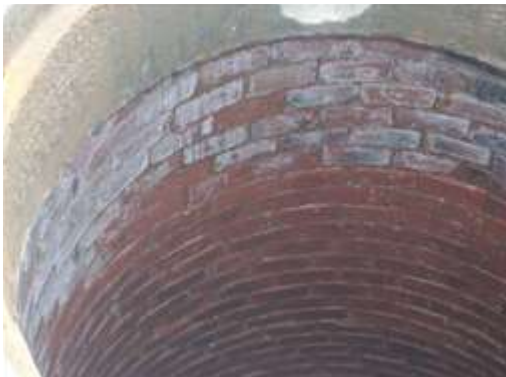
Defect 3

Surcharge ☒ **Evidence Of Surcharge** Depth: **6** (ft.) ☐ Active Surcharge Present

SURCHARGE EVIDENCE ON WALL

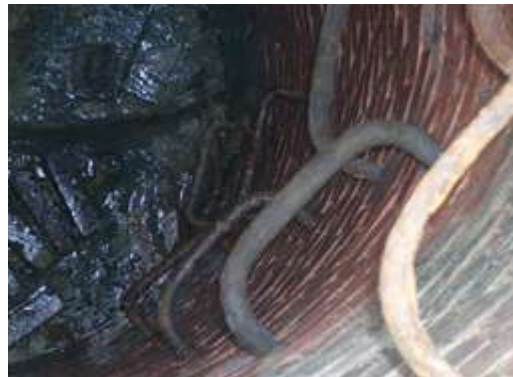
Defect 2

Steps Count: **7** Missing: **0** ☒ **Corroded**

CORRODED STEPS

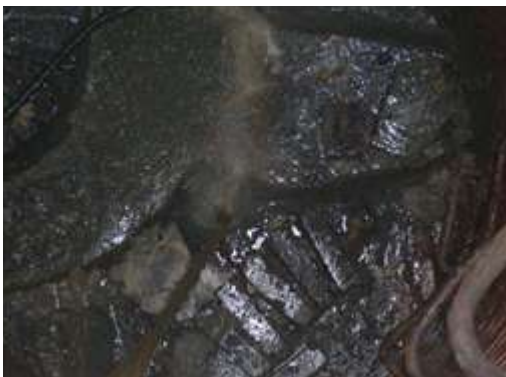
Defect 1

Condition: ☐ Sound ☐ Cracked ☐ Root Intrusion ☒ **Deteriorated** ☐ Leaks ☐ Debris

DETERIORATION OF BENCH

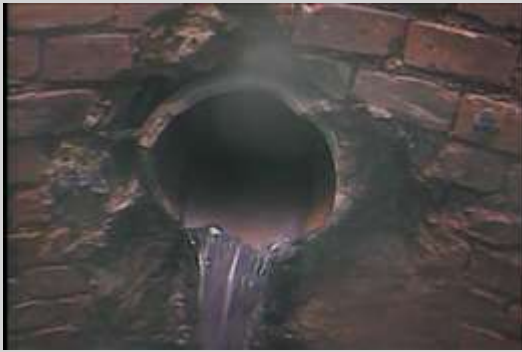
7 O'Clock Inflow

CORRODED STEPS

Deposits: ☐ None ☐ Mud ☐ Sludge ☒ **Debris** ☐ Grease

Silt Depth: **2** (in.) Deposits Extent: **Medium**

Infiltration: **None** Pipe Seal Cond: **Broken**

Drop Condition: **Partly Clogged**
